1. AGENCY USE ONLY (Leave Blank)		2. REPORT DATE October 1991		3. REPORT TYPE AND DATES COVERED Interim	
4. TITLE AND SUBTITLE Human Factors Assessment of USCG				5. FUNDING NUMBERS 69X0243

6. AUTHOR(S) LCDR F. D. Holcombe, MSC, USN and LT S. C. Webb, MSC, USNR					
7. PERFORMING ORGANIZATION NAME(S) AND ADDRESS(ES) Naval Biodynamics Laboratory P. O. Box 29407 New Orleans, LA 70189-0407				8. PERFORMING ORGANIZATION REPORT NUMBER NBDL-91R003

13. ABSTRACT (Maximum 200 words) Part I documents the ergonomic and safety deficiencies noted during an on-site familiarization and inspection of the prototype 47-ft motor lifeboat. The following human factors operability and habitability problem areas are addressed: steps, platforms, and railings; doors hatches, and passageways; controls; instruments and displays; workspace; and habitability considerations. Approaches to problems are indicated in the form of suggestions for possible redesign, reconfiguration, relocation, or replacement of equipment. Deficiencies fall into these categories: design of ladders; design and configuration of hatches; location and arrangement of controls, instruments, and displays; design of seating; and workspace

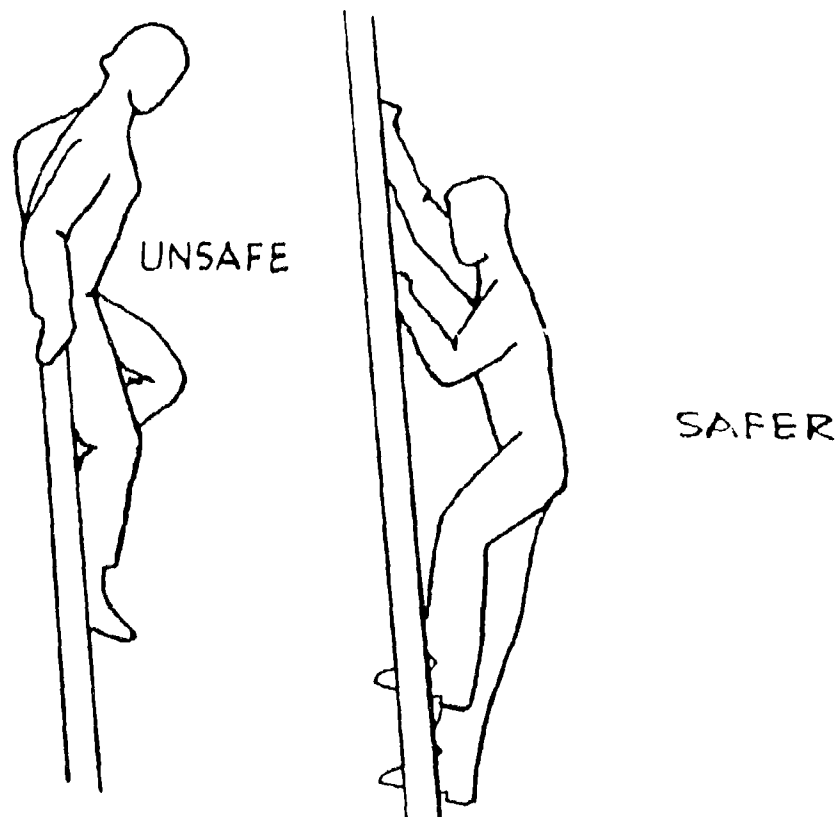
- If the steps are wet, a slipping/falling hazard exists.

Figure I.2. Appropriate and inappropriate ways of descending a ladder.

- Provide a safety screen behind the ladder (steps) to prevent slipping between the steps.
- Curb or round off the aft deck step to prevent crew from tripping "up" the ladder/steps. Aft platform should be flush with the end of the riser, thereby eliminating the tripping hazard.
- The "lips" of the deck meet the grating of the recessed deck. However, the end of the grating deck should be extended and closed, if possible.
- Install a railing on the bulkhead just below the recessed deck grating in order for crew to brace themselves in a kneeling position while recovering overboard people or objects.
- This railing should extend 4 inches from the bulkhead for hand clearance; the railing would also afford more flexibility than the "D" ring restraints; top of aft platform is a knife edge.

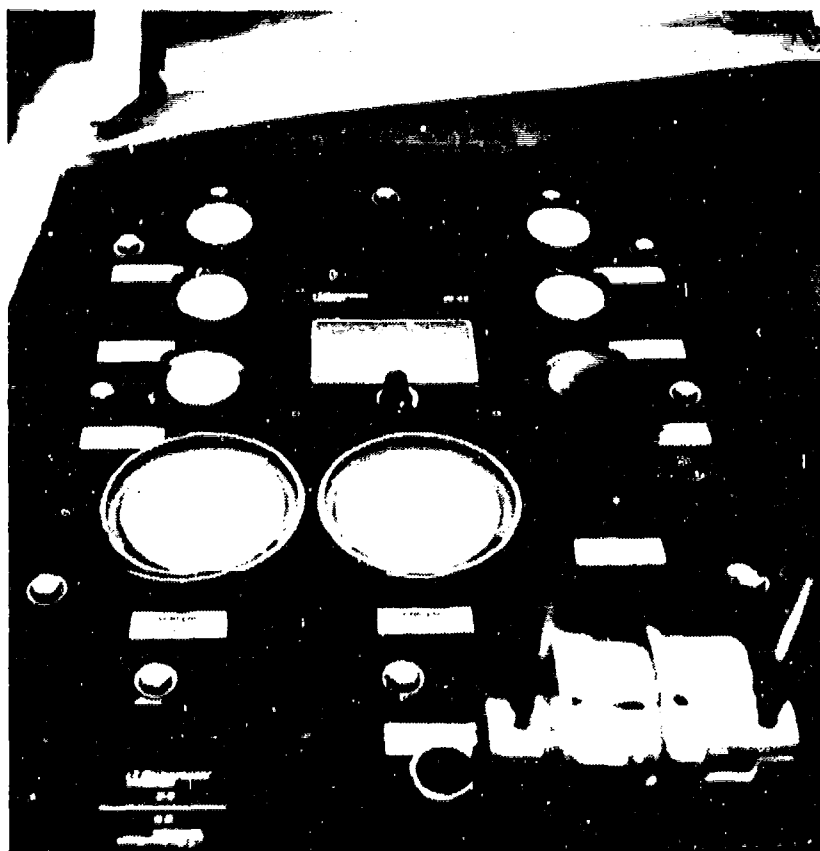
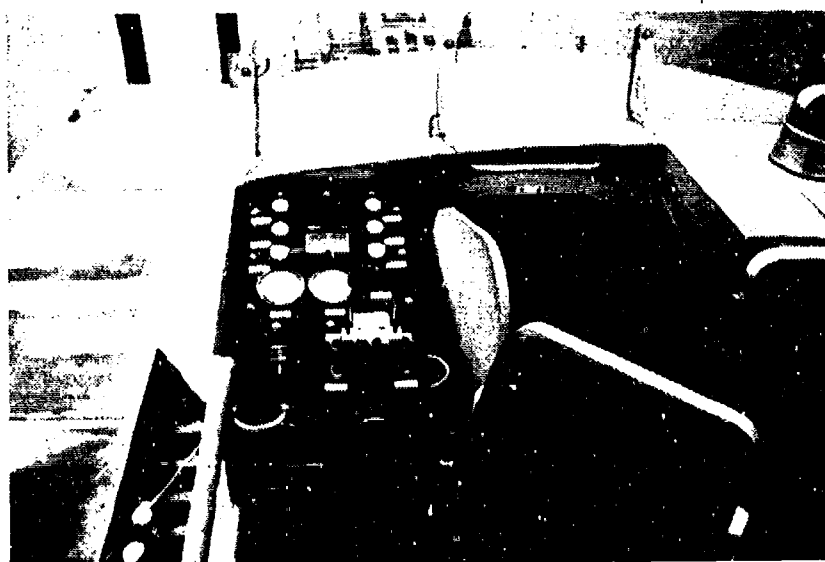
Figure II.3. Port steering station open bridge.

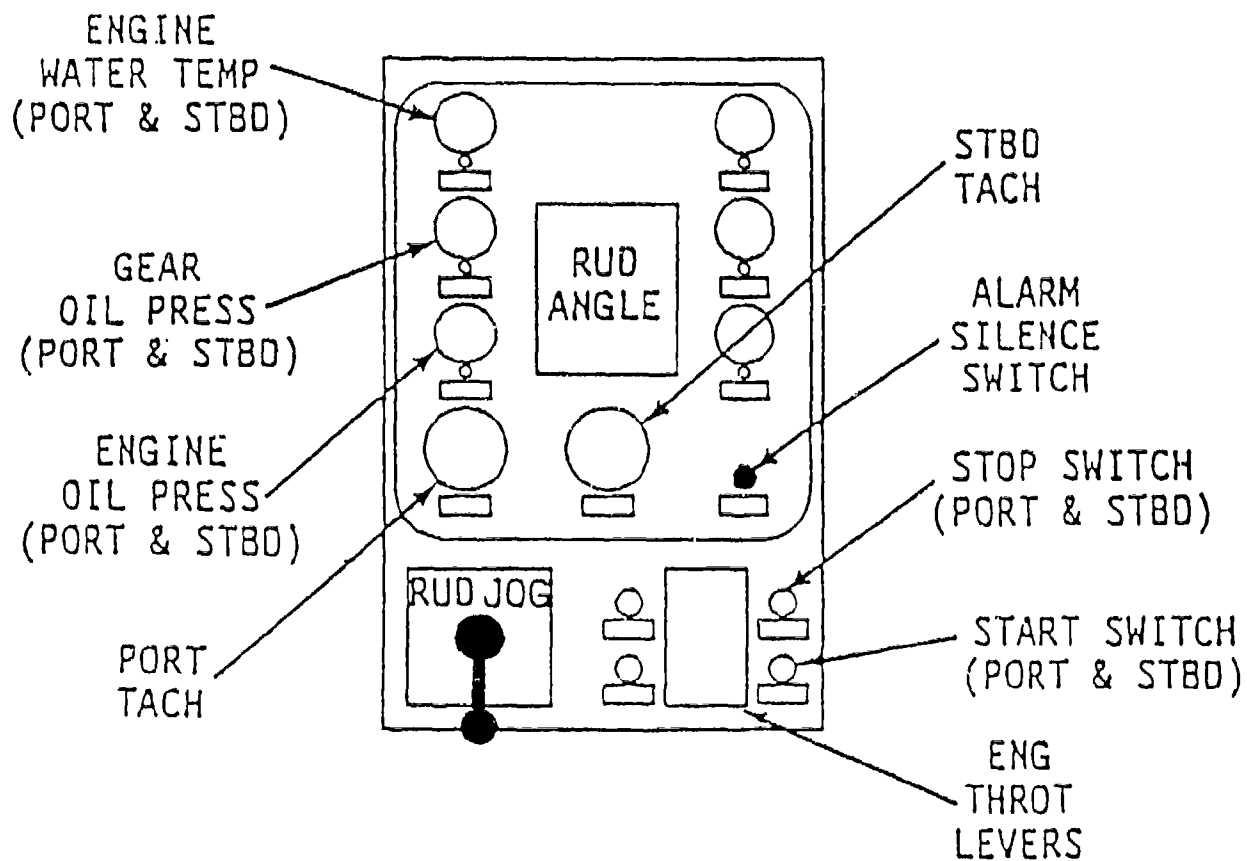
Figure II.4. Port steering station on open bridge.

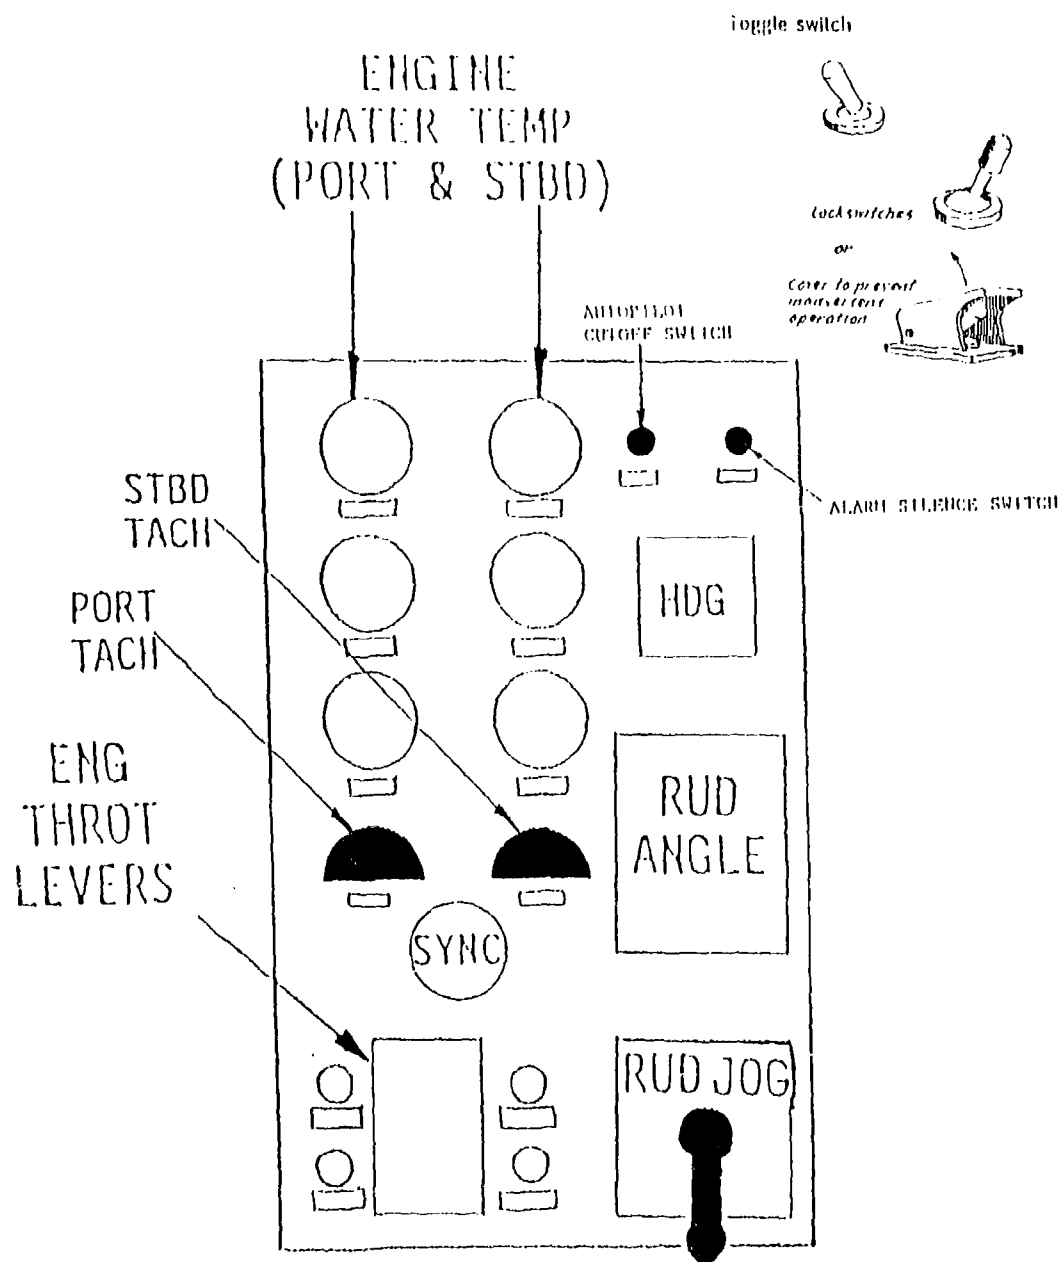
Figure II.6. Proposed autopilot cutoff switch on open bridge.

- Place an autopilot cutoff switch above the heading indicator on the port steering station console. A standard two-position toggle switch with a locking mechanism or protective cover to prevent inadvertent activation is recommended (see Figure II.6). The same type of mechanism is recommended for the alarm silence switch. The recommended minimum distance between the two toggle switches

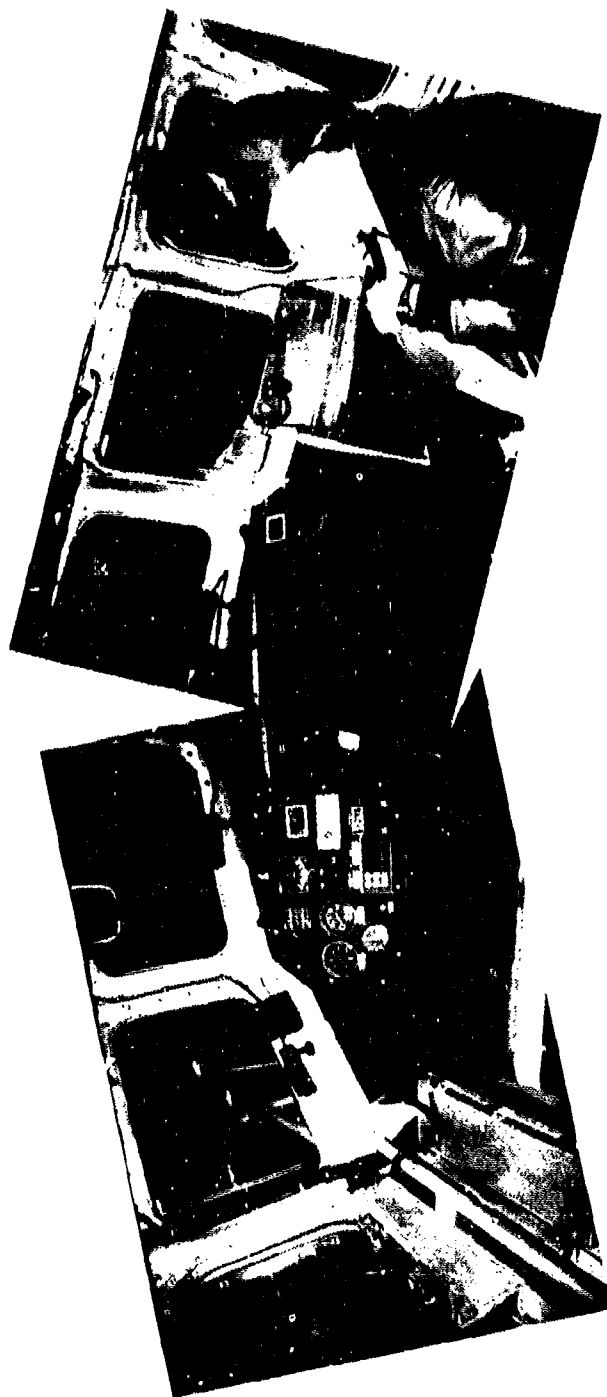
Figure II.11. Wide angle view of enclosed bridge.

- Relocate controls and displays from the center console to the dashboard or overhead. The center console would be eliminated from the current enclosed bridge configuration. In this configuration the throttle control is mounted on a centerline panel, allowing both operators free movement to enter and exit their chairs (see Figure II.12). The Loran-C may be relocated to the aft side of the centerline panel and accessible to both operators. Another possible location for the Loran-C would be in a position under the proposed centerline mount.
- Relocate outboard port and starboard electrical panels (see Figures II.13 and II.14) to a watertight compartment accessible to the engineering crew. It is recommended that the panels be relocated

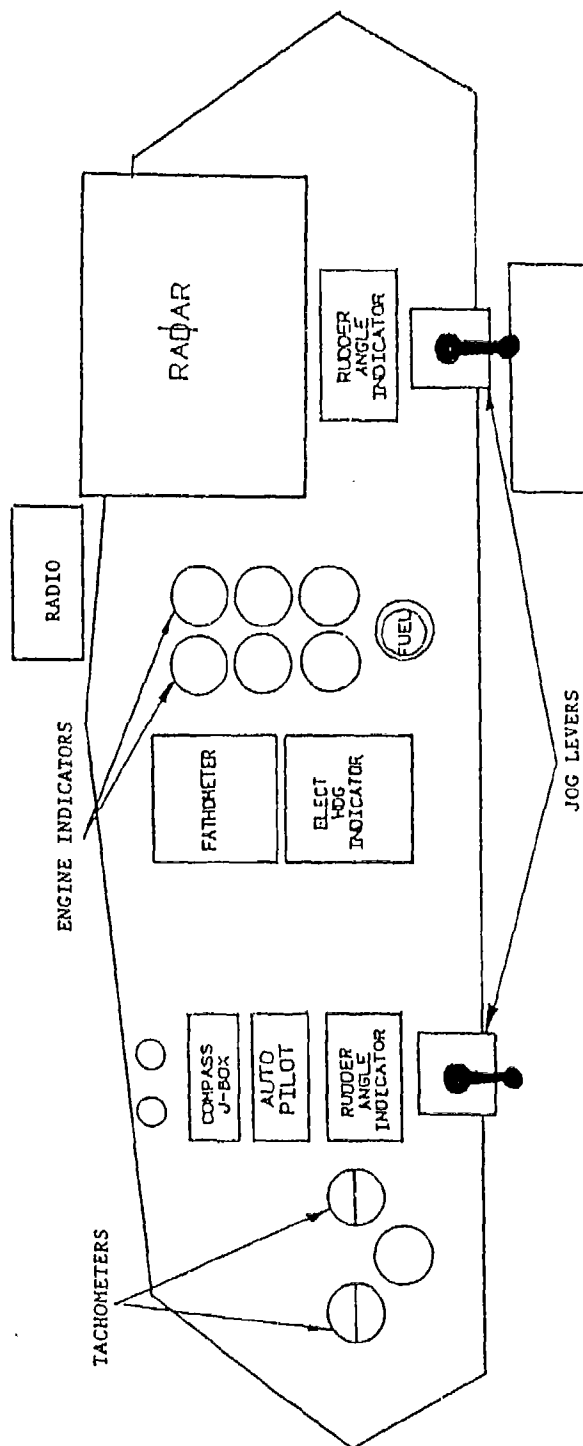
Figure II.17. Proposed enclosed bridge layout.

- Relocate the enclosed bridge jog levers from the operator chairs to the dashboard/console in the horizontal position (see Figure II.17). Operators are usually in a standing position when conducting mooring and other critical maneuvers. Moreover, the relocation of the levers will allow the operators to operate the lever controls comfortably (in both sitting and standing positions). This design incorporates the proposed centerline throttle position. The jog

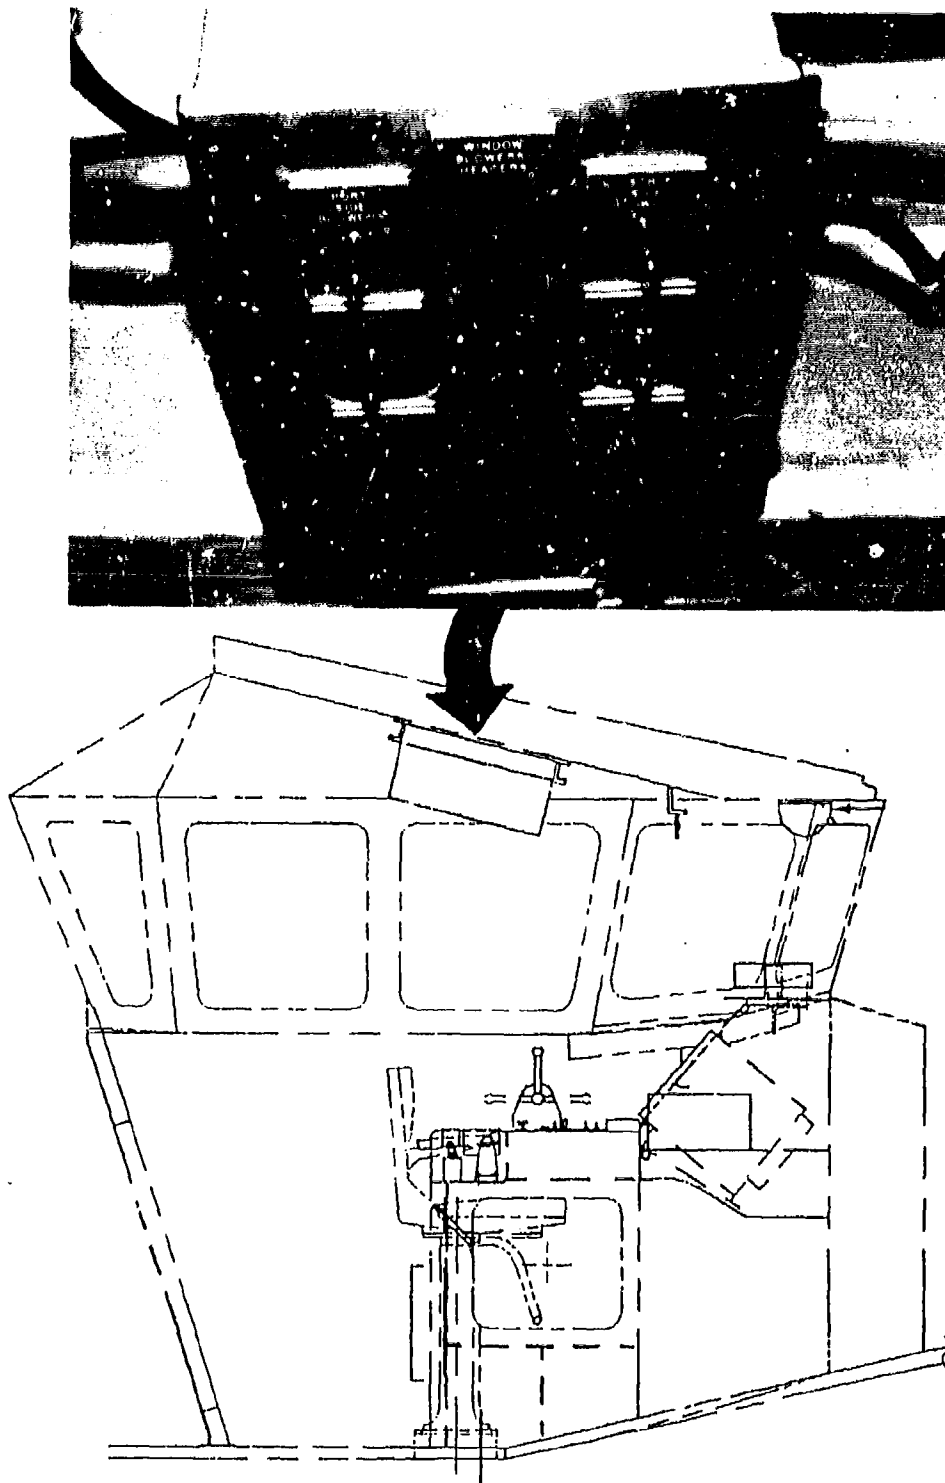
Figure II.22. Window/heaters junction box in enclosed bridge overhead.

- Provide a locking mechanism on the hinged windows that is shock and vibration resistant. Remove the plate covering the lower window frame. Redesign the window latching mechanism to ease the operation of the window and label the correct movement of the latch handle to open and close the window.

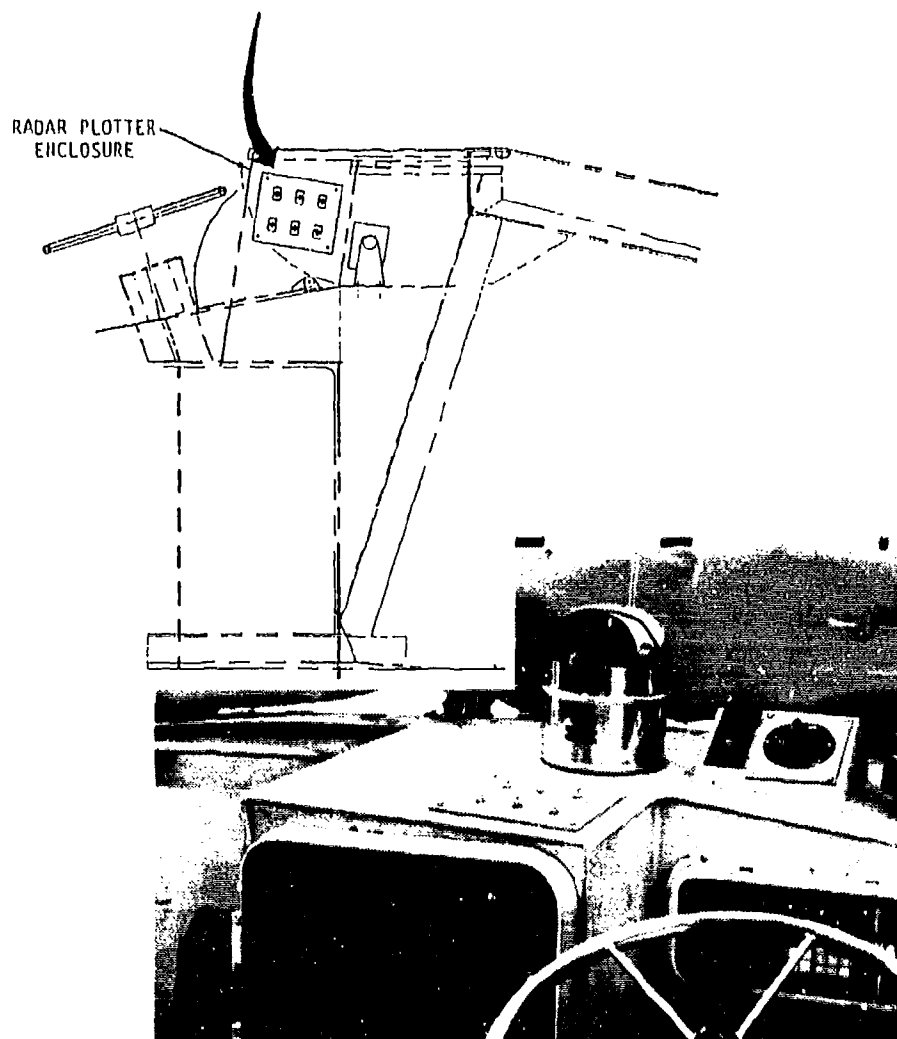
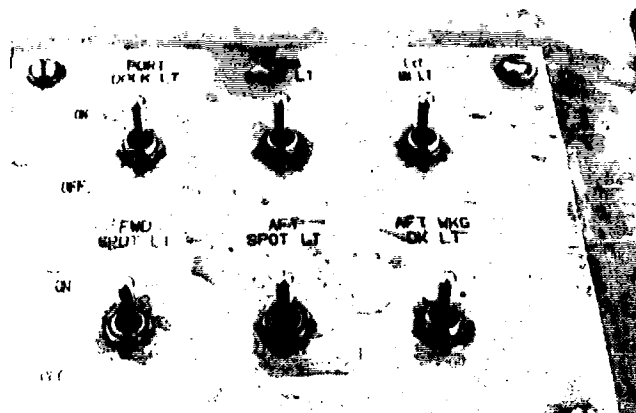
Figure II.23. Open bridge navigation and lighting switch panel.

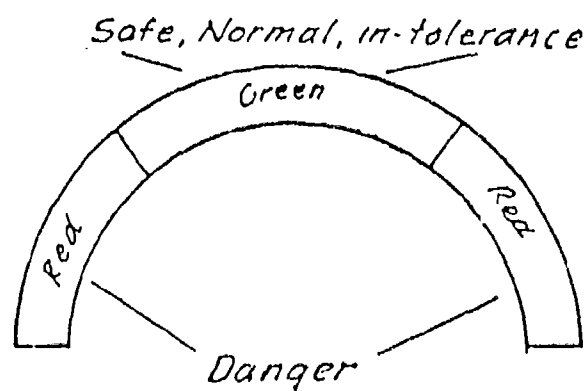
- The green-red combination used on the current tachometer gauge is adequate in discriminating between the safe and unsafe rpm limits of the engine. However, it may be recommended that a third color be used in the gauge display. For example, the color yellow can be used to indicate marginal operating parameters. Figure II.26 illustrates both the current and the proposed color coding configurations for the tachometer gauges. The standard colors can be used for both round and half round gauges (discussed above).
- Situational factors (low ambient light/illumination, inclement weather, operator workload) will have negligible effects on the reading of the color coded tachometer gauges.

Figure II.26. Color codes for engine indicators.

- The color coding of the tachometers gauges should be painted on the face (interior) of the gauge once the tolerance limits have been determined by test crew engineers. This would protect the color coding from inclement weather, water, moisture, and conditions of extreme heat or cold. The use of plastic colored strips is not recommended.

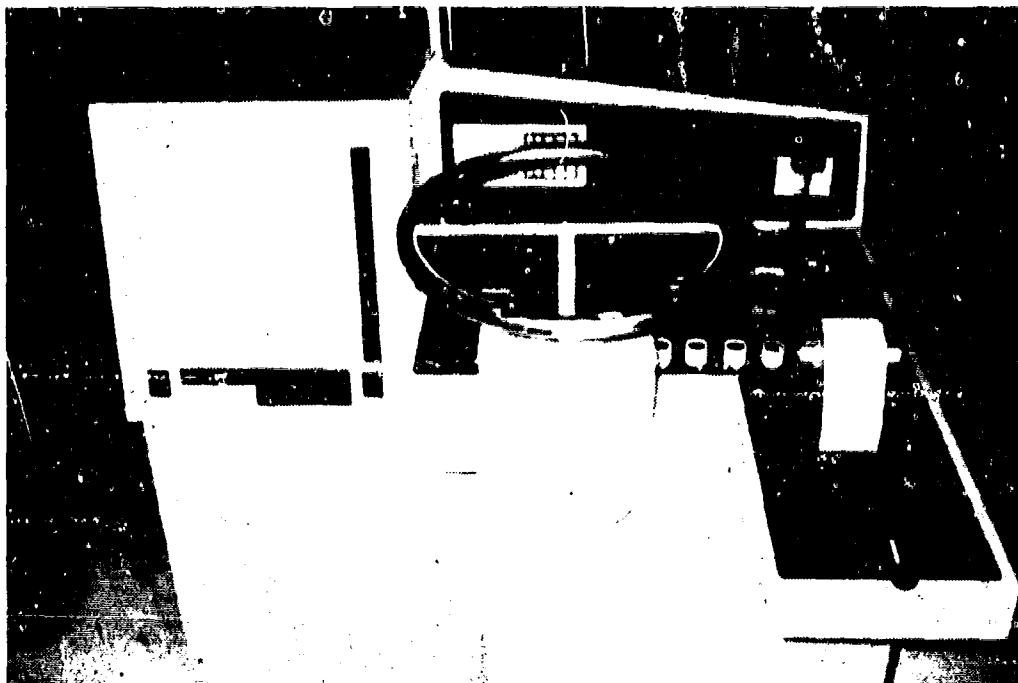
Figure A4a. Current starboard open bridge steering station mock-up.

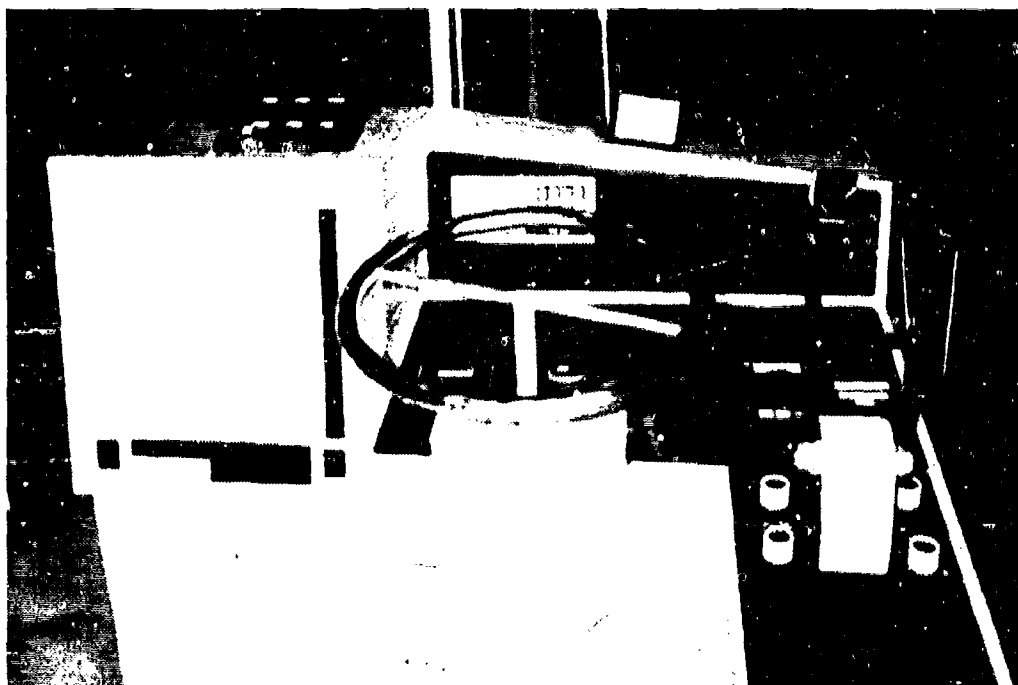
Figure A4b. Proposed starboard open bridge steering station mock-up.

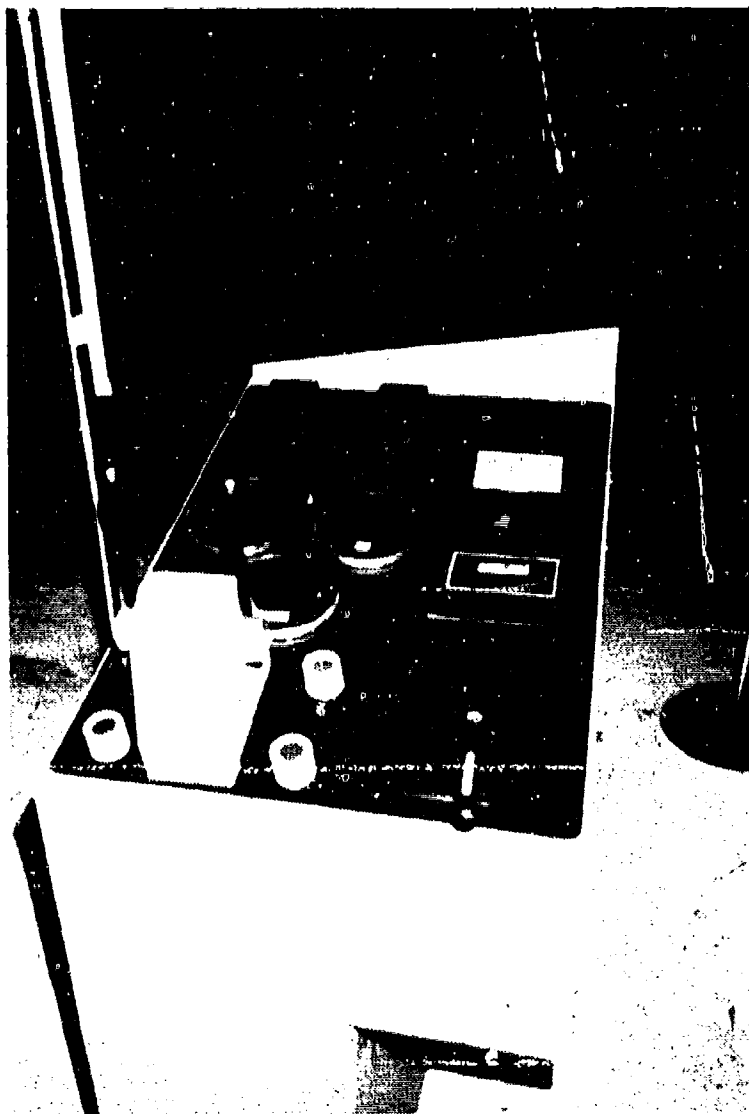
Figure A5. Port open bridge steering station mock-up (proposed configuration).
